Case Study Waithe Beck, Brigsley III

Chalk Streams
of Lincolnshire

The Lincolnshire Chalk Streams Project
Tel: 01507 609740
www.lincswolds.org.uk

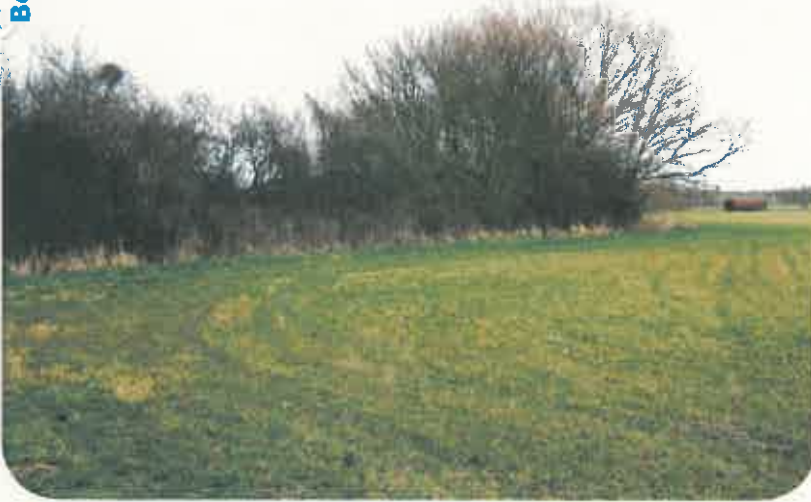
Before

218 metres of meandering channel that has been dredged in the past. The spoil has been deposited on the banks, disconnecting the stream from the flood plain. Scrub has developed on this bund which severely limits marginal plant growth.

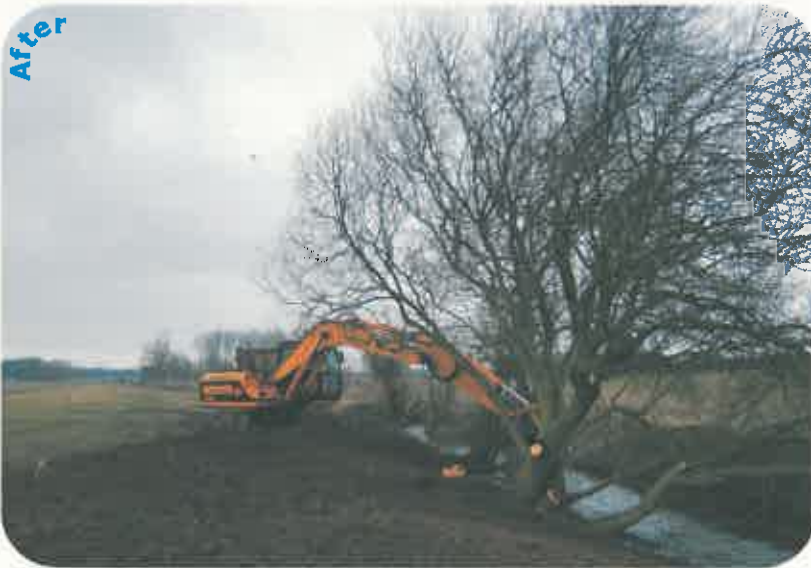
After

This final section of work has completed over one kilometre of restoration. The stream is now a central feature of the farm and is perfect for the morning stroll!

- 218m of scrub removal.
- 218m of spoil removed from the bank top.
